A Fluvial Geomorphic and Sediment Transport Study of the Little River Upstream of Lake Thunderbird Using an Acoustic Doppler Current Profiler (ADCP)

PROJECT REPORT

May 2011

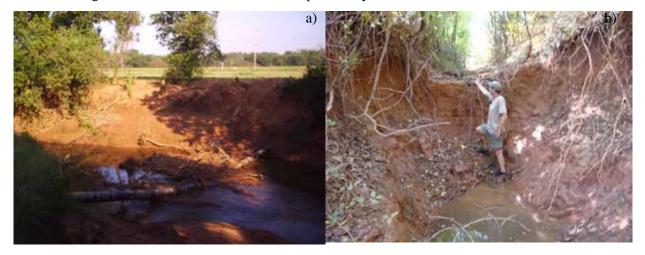
Figure 1: Indications of the Little River channel incision and widening including a) an exposed high pressure gas line and b) tributary head cuts.

Lane (1955) described that the morphology of a channel is the result of several factors, including the sediment load and size transported through the channel, the discharge in the channel and the slope of the channel. The size and load of sediment transported through a channel is balanced by the stream slope and discharge. If the balance is altered, the channel morphology adjusts to accommodate the change. Schumm, et al (1984), and later Simon (Simon, 1989, 1994) developed a process-based classification scheme that describes a natural channel's adaptation to straightening. As shown in Figure 2, the Channel Evolution Model describes a complete "cycle" of bank-slope development from the pre-modified conditions through stages of adjustment to the eventual reestablishment of stable bank conditions. The Little River channel bed, in the reach surveyed in the vicinity of 12th Avenue NE, appears to have recently entered Stage IV of the evolutionary cycle, the degradation and widening phase, and appears to have incised at least 6-8 feet thus far.

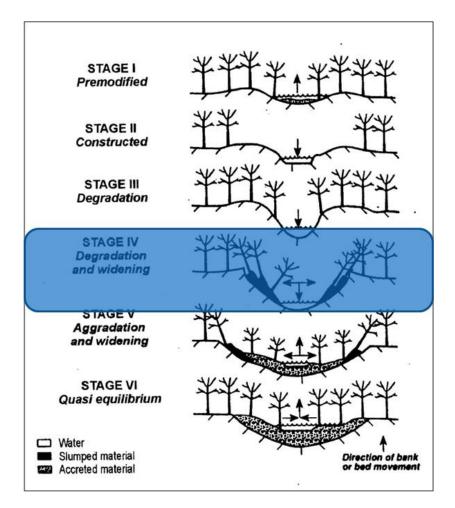
Figure 2: Channel Evolution Model – The Little River is currently at Stage IV, the degradation and widening stage. (Simon (1989))

The results thus far are not surprising. They show a channel that is entrenched, with a Rosgen classification of F5 and G5c, and getting wider and deeper, with a channel evolution stage of IV. Practically every metric at every site assessed indicates that the channel is unstable or highly unstable with high to extreme near bank stress. Three other sites have been surveyed but the data has not yet been processed for inclusion in this report.

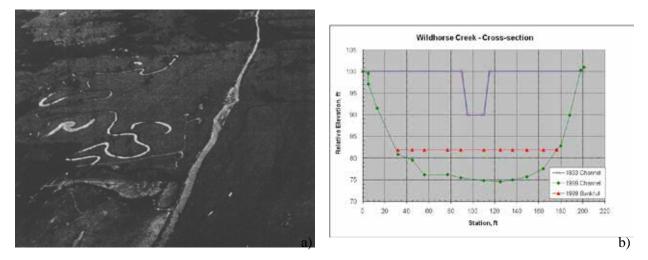
To fully understand the significance of this process, one needs only to look at Wildhorse Creek, near Hoover, in Garvin County, Oklahoma. Between 1922 and 1933 the channel was "improved" by constructing a straight 10 feet deep trapezoidal channel with a top width of 25 feet and 2:1 side slopes, as may be seen in Figure 3a (Barclay, 1980). In 1999, Dutnell (2000) found the channel to be 193 feet wide and approximately 25 feet deep. The channel has thus incised approximately 15 feet and experienced a 20-fold increase in cross-sectional area (Figure 3b). It appeared to be at Stage V, the aggradation and widening phase, as there was evidence of deposition on inside bends and point bars were beginning to form. As a result of the experienced erosion, the sediment loading to Lake Texoma, since the "channel improvements" were completed, exceeds 50 million cubic yards.

Figure 3: a) Channelized versus natural meandering Wildhorse Creek channel, in Garvin County, Oklahoma (Barclay, 1980); b) Comparison of Wildhorse Creek channel dimensions in 1933 (Barclay, 1980) and 1999 (Dutnell, 2000)

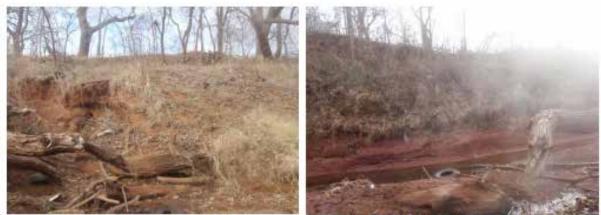
Figure 3: LR-02 Cross Section - Left Bank.
