SILTING AND FOREST SUCCESSION ON DEEP FORK IN SOUTHWESTERN CREEK COUNTY, OKLAHOMA

H. I. Featherly, Stillwater

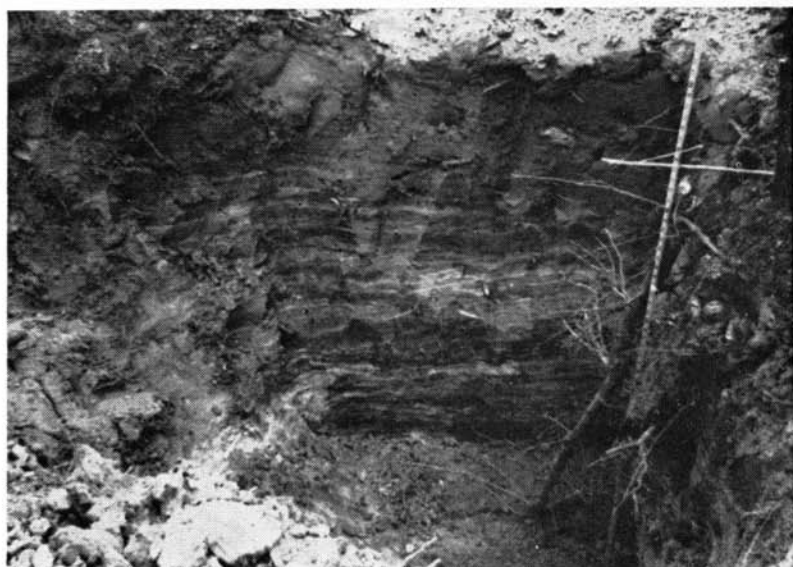
FIG. 4—Excavation from which ash tree shown on chart was dug. Note layers of sedimentary soil. Location: N. W. $\frac{1}{4}$, Sec. 33, T. 14N., R. 7E.

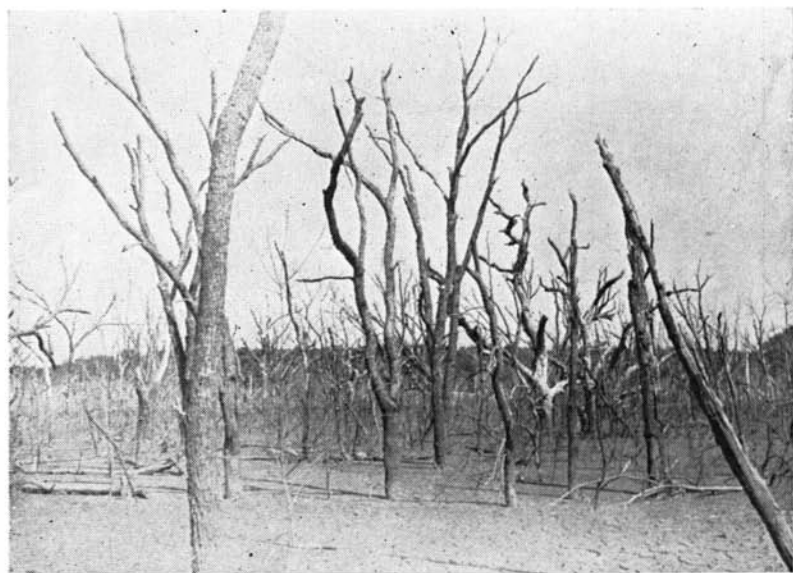
FIG. 5—Dead trees of old forest. Under water most of the year. Location: S. E. $\frac{1}{4}$, Sec. 30, T. 14N., R. 7E.

The flood plain of the stream was originally covered with an oak-hickory forest composed mostly of *Quercus macrocarpa*, *Quercus borealis*, *Carya illinoensis*, *Ulmus americana*, *Populus deltoides*, and *Fraxinus lanceolata* with a predominance of oaks and hickories. These oak and hickory trees are characteristic of well drained bottom land. At the present time these trees are all dead except a few in places on the natural levees along the original stream where the soil is sandy and drains quickly after the floods pass. Sediment deposited around the trees has gradually shut off the oxygen supply. This alone would have killed the trees except in the shallower deposits. In addition to this, the water table in the entire flood plain has been raised above the roots of the original forest, thus adding another lethal factor. With the original forest destroyed and the water table brought near the surface, the place is ideal for the starting of trees more tolerant of water; hence, over a large part of this flood plain there now exists a young forest of *Fraxinus lanceolata*, *Populus deltoides*, and *Salix nigra*. These are roughly arranged with the *Fraxinus* on the higher sandier soil, *Populus deltoides* next, and the willows in the more moist places. A considerable part of the area is under water too much of the time to have any living trees at all (Fig. 5). The young trees now present have
