WINTER ICE REMOVAL FROM STOCK PONDS

Dr. James E. Garton, Professor
Dr. Tesfai Ghermazien, Research Associate
Kerry Robinson, Research Assistant
Department of Agricultural Engineering
OKLAHOMA STATE UNIVERSITY

OKLAHOMA WATER RESOURCES RESEARCH INSTITUTE
Period Covered by Research Investigation
October 1, 1978 through September 30, 1980

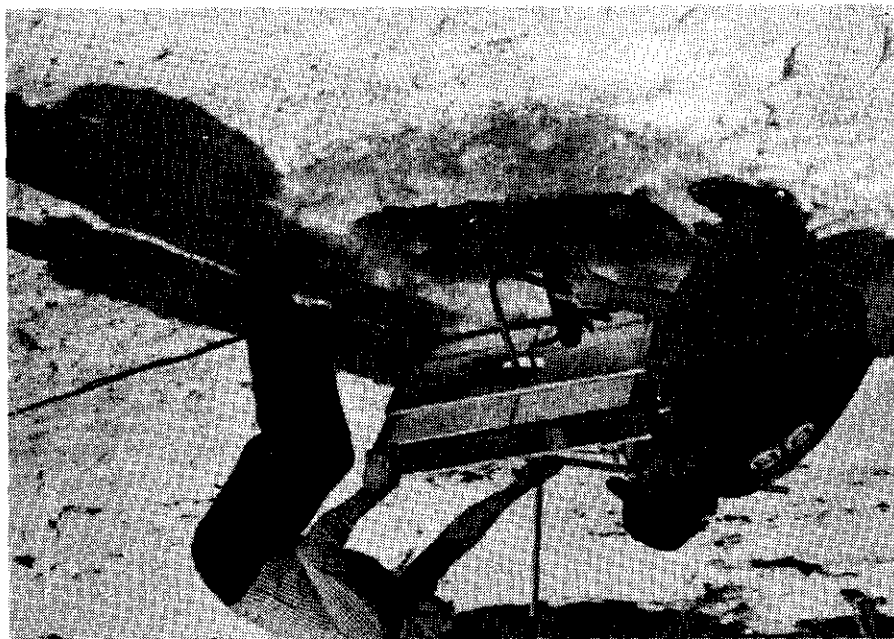
Figure 3. Installing the Thruster Electric
Outboard. 1979.

The Thruster Electric Outboard was powered by the 12-volt battery which was enclosed in the white box as shown in Figure 2. The raft that carried the propeller (Figure 3) was connected to the anchor-pole by two connecting rods. The pole was driven into the pond bottom. This connection was made in such a way as to allow free movement of the raft as the elevation of the water level changes. Free movement of the raft was achieved by hinging the connecting rods to the raft and the anchor-pole and allowing enough height of the anchor-pole above the water level so the lower connecting rod would not interfere with the raft movement.

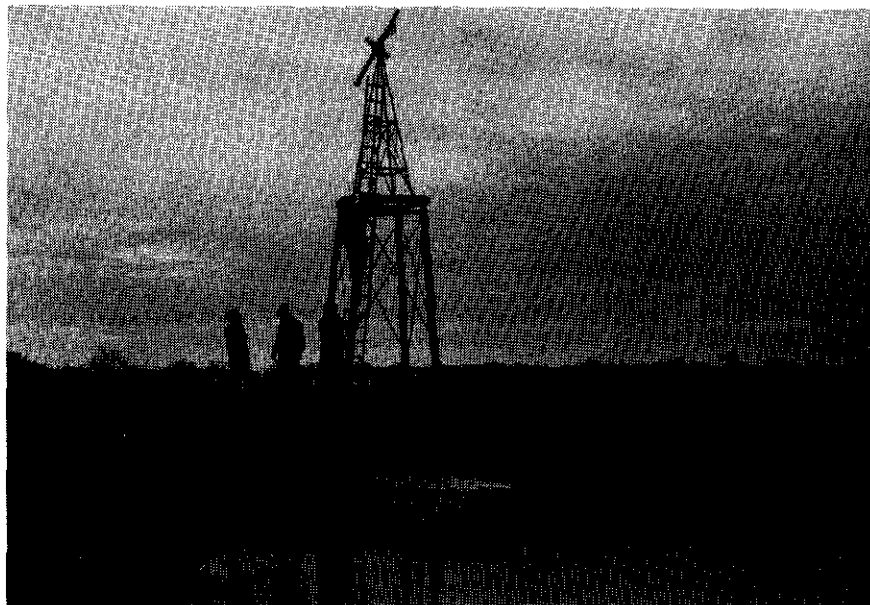
Figure 6. View of Completed Wind Generator Installation

A 12 volt wind-driven generator (Wincharger - Figure 5 and 6) was used to power an electric outboard trolling motor (Figures 7, 8, and 9). The trolling motor was attached to a redwood raft which was 0.6 meters wide and 0.9 meters long. The trolling motor propellor extended approximately 0.4 meters below the water surface and was directed toward shore at an angle of 45 degrees from the horizontal. The raft that supported the trolling motor was connected to an anchor pole by two 1.1 meter connecting links. The connector links allowed vertical movement of the raft as the water level changed. The trolling motor speed control was mounted on another pole above maximum water level. The Wincharger was mounted on a 7.6 meter tower to place it above surrounding obstructions to air flow. Heavy duty waterproof conductor was buried between the Wincharger and trolling motor control, Figure 10. The wire was encased in pipe at the shoreline to prevent cattle from "tramping" it out. The wind generator was connected directly to the

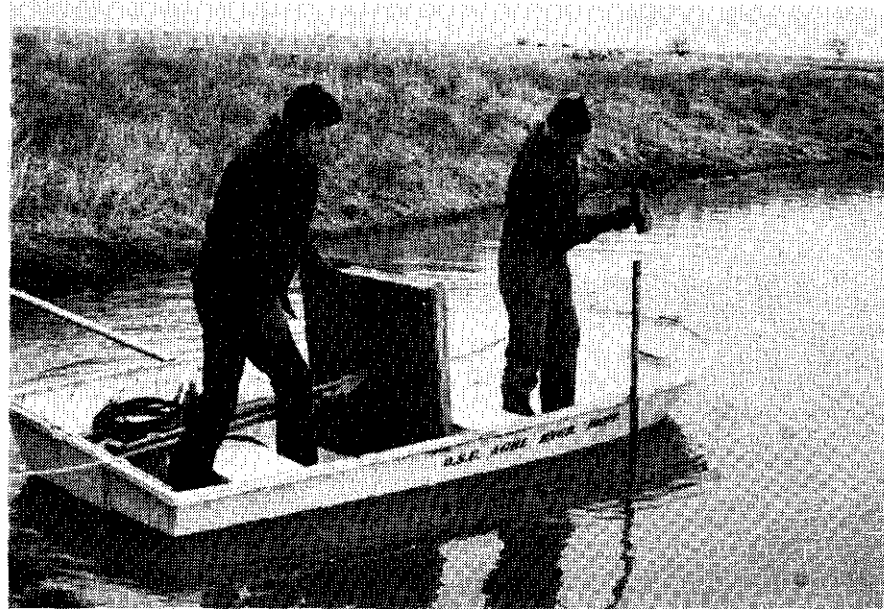
Figure 7. Installing Anchor Pole

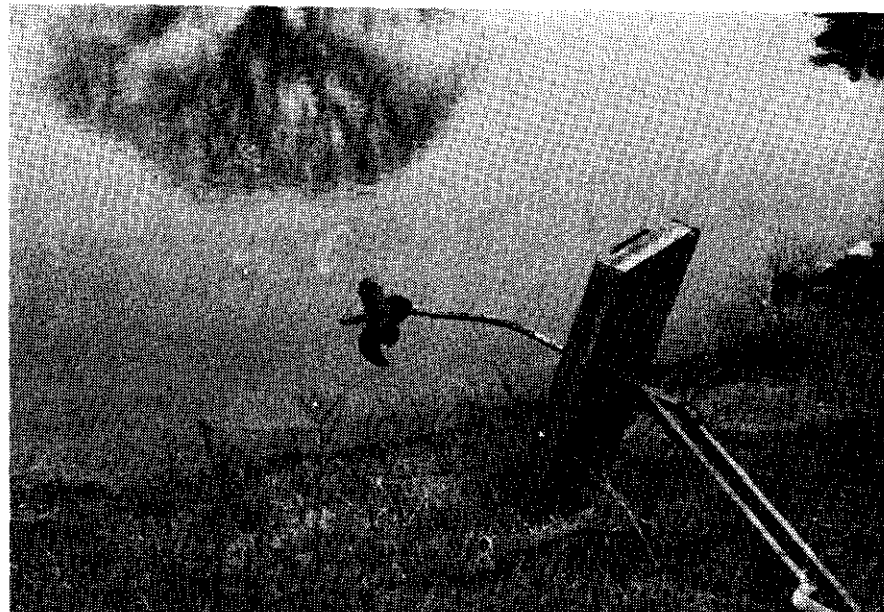
Figure 8. View of Raft and Troller Motor

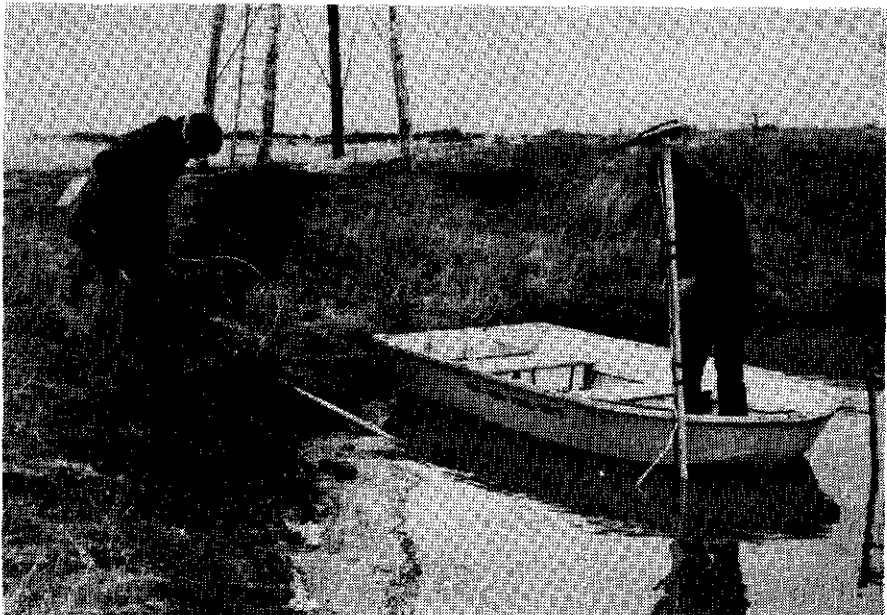
Figure 10. View of Wiring Burial

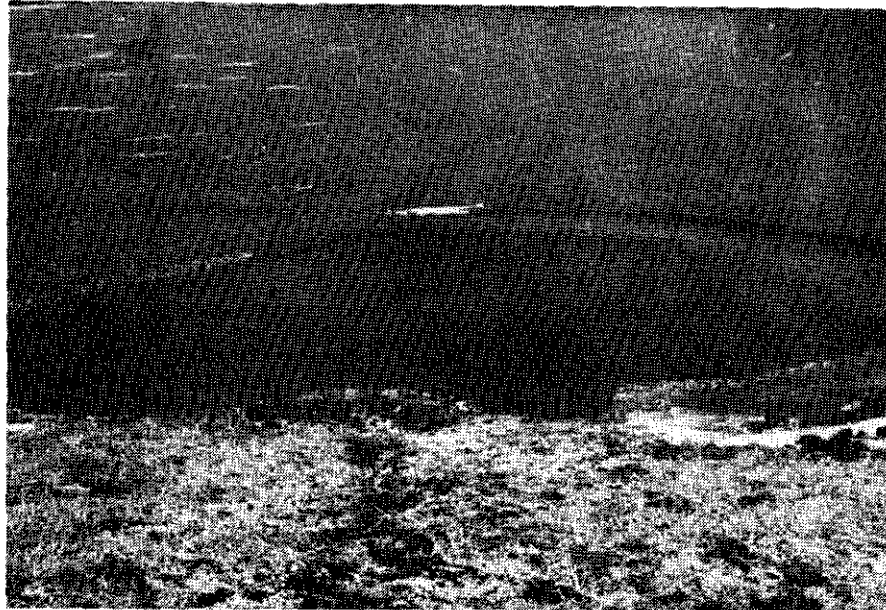
Figure 17. View of Ice Hole Configuration on 31 January 1980
for the East Pond Submersible Pump

The discharge was directed toward the shore at a 45 degree angle from the horizontal. Generally, the resulting ice hole was elliptical-shaped, with the long axis toward shore.
