# Extraction of Zinc from Airport Stormwater Runoff using Oyster Shells

Thomas Long  
*Kent State University*

Lu Zou  
*Kent State University*

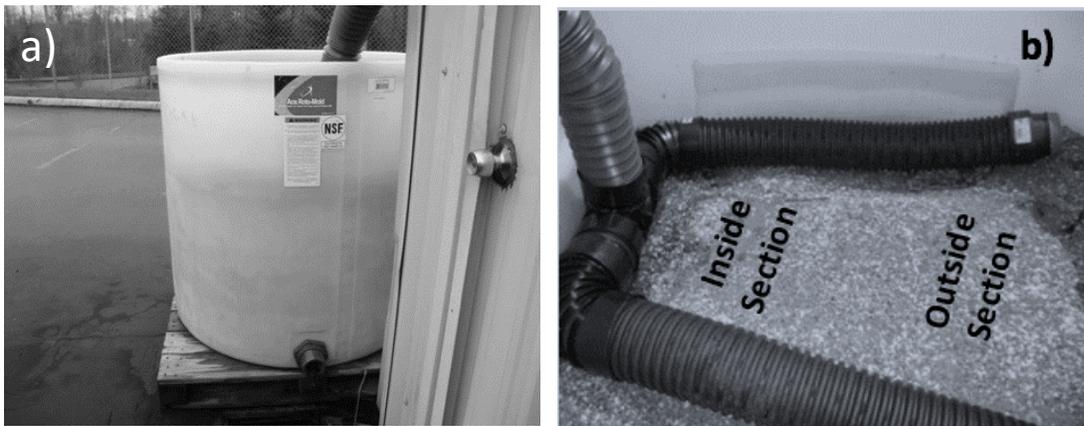
Figure 2(a) shows the cylindrical tank located at hangar C18-NE. Figure 2(b) is a typical view peering into the tank from the top, displaying the two areas (inside and outside sections) from which medium samples were collected, and later analyzed in the laboratory. A sample of fragmented oyster shells was provided to the researchers to be used to establish the starting level of Zn on the shells before they were used as part of the medium in the tanks.

Figure 2. (a) The cylindrical tank for C18-NE being tested. (b) Locations where samples were collected.

The results of the ICP-OES analyses of the samples of the medium from the two tanks indicate that the outside sections of the tanks “outperformed” the inside sections in terms of the extraction of Zn from the stormwater. Figure 2(b) shows the arrangement of the perforated pipes that allows the inflowing stormwater to be distributed across the top of the tank, which results in more water entering and filtering through the outside section of the tank. The sample from the inside section of the tank at hangar C18-NW contained an average (for three “runs”) concentration of Zn of 10,158 ug/g dw (micrograms per gram in dry weight); in the sample from the outside section of this tank, the analyses showed a concentration of Zn of 13,616 ug/g dw. Results were comparable for the samples from the tank at hangar C17-SE – concentrations of Zn were greater in samples from the outside section of the tank (Tables 5 and 6).
