THERMOGRAPHIC DETECTION OF LOCAL HEATING DURING CYCLIC LOADING

J. A. Charles, F. J. Appl, and J. E. Francis

School of Aerospace, Mechanical, and Nuclear Engineering, University of Oklahoma, Norman, Oklahoma

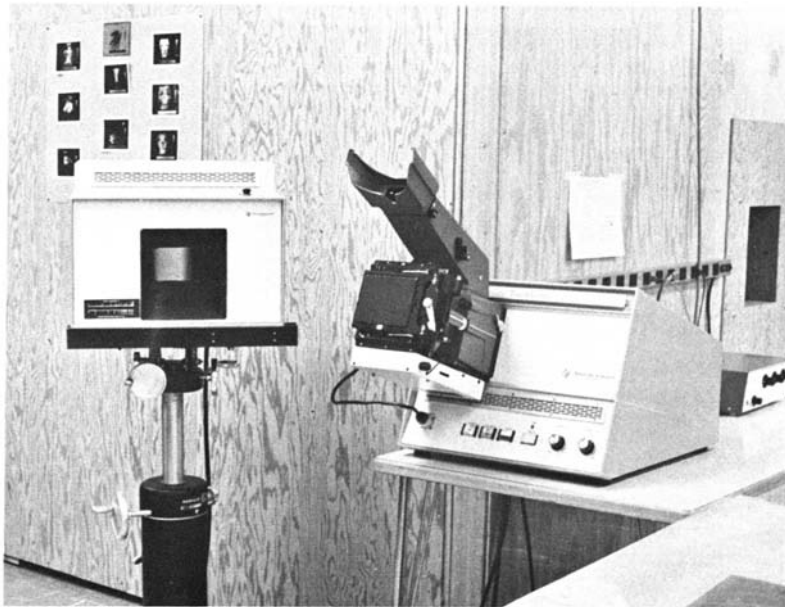
Figure 1. Scanning infrared camera showing scanner (left) and recorder (right).

The scanning infrared camera used in this study is shown in Figure 1. It consists of a scanner, a recorder, and a camera. The scanner was designed to detect radiation in the 8μ to 14μ wavelength range using a liquid nitrogen-cooled mercury cadmium telluride detector. One scan of the viewing field takes 4.5 sec and results in 525 horizontal lines each containing 525 elements. The detected radiation is then converted to a visual image in the recorder and displayed on a cathode-ray tube, where it can be photographed for a permanent record. This photograph, a visualization of the surface temperatures of the object of interest, is termed a "thermogram". An internally-generated reference scale also appears in the thermograms as an indication of the temperature range covered in each case. The temperature level and range are adjustable, at the recorder, to cover 60 F to 120 F ranges which may vary from one to 20 degrees.
